Manhole Inspection Summary

Manhole # S51AA_026MH

Insp Date: **7/17/08 12:04 PM**

Location Address: **rear 735 n kenwood av**

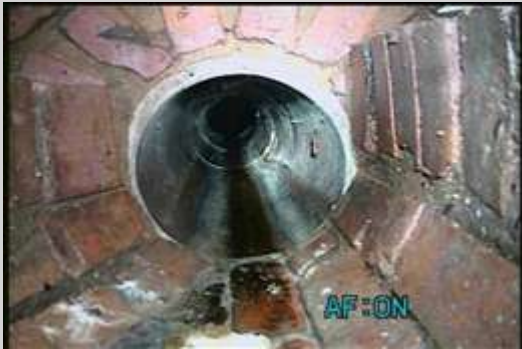
12 O'Clock Outflow

8 in. Circular Gravity Sewer
Pipe Out @ 12 O'Clock

Pipe Material: **Clay** ☐ Pipe Lined

Invert Depth: **9.00** (ft.) Flow Characteristics: **Slow**

Deposits: ☒ None ☐ Mud ☐ Sludge ☐ Debris ☐ Grease

Infiltration: **None** Pipe Seal Cond: **Unknown**

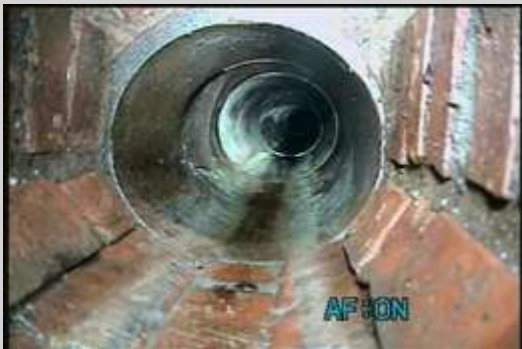
6 O'Clock Inflow

8 in. Circular Gravity Sewer
Pipe In @ 6 O'Clock

Pipe Material: **Clay** ☐ Pipe Lined

Invert Depth: **8.90** (ft.) Flow Characteristics: **None**

Deposits: ☒ None ☐ Mud ☐ Sludge ☐ Debris ☐ Grease

Infiltration: **None** Pipe Seal Cond: **Unknown**

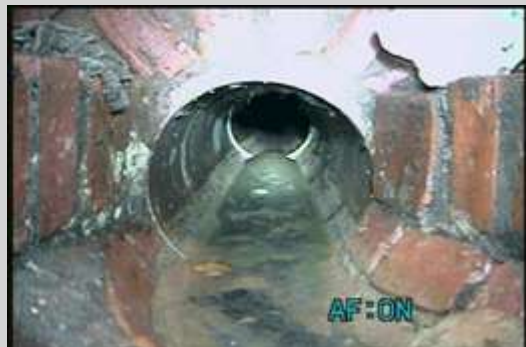
9 O'Clock Inflow

8 in. Circular Gravity Sewer
Pipe In @ 9 O'Clock

Pipe Material: **Clay** ☐ Pipe Lined

Infiltration: **None** Pipe Seal Cond: **Unknown**
